NASA Technical Memorandum 104264

Ground Vibration and Flight Flutter Tests of the Single-Seat F-16XL Aircraft With a Modified Wing

David F. Voracek

June 1993

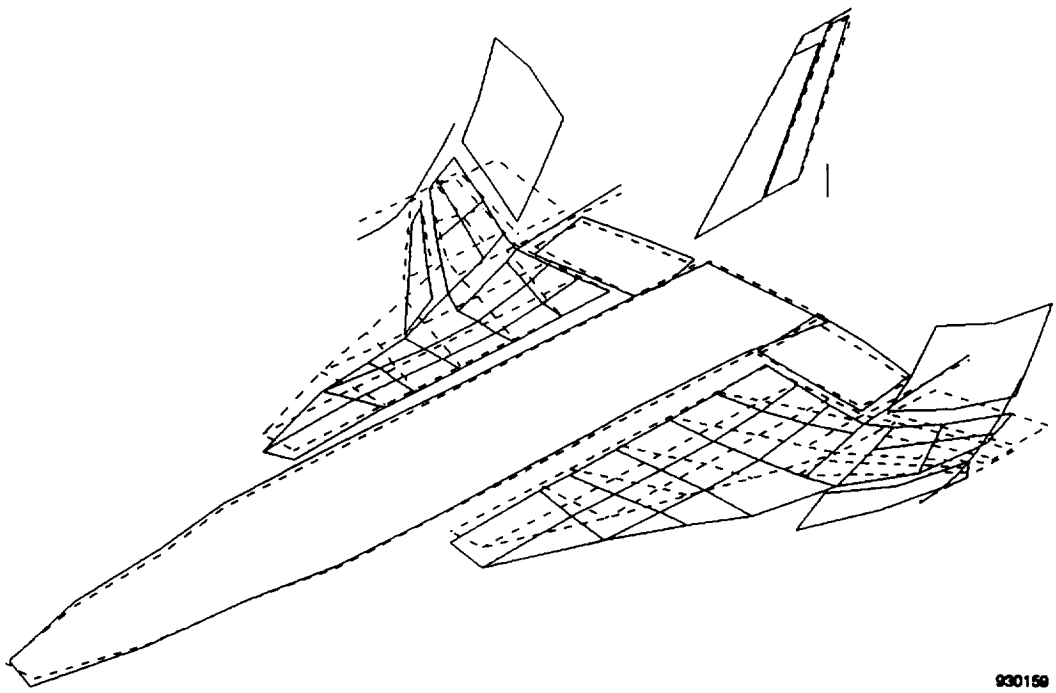
Figure 16. Aircraft mode shapes, symmetric control surface mode 2.

The first difference is the absence of a 26.4-Hz symmetric control surface mode in the modified aircraft GVT data. Figure 16 shows the baseline mode shape. The absence of this mode in the modified aircraft data is likely a result of the changes in the wing mass and stiffness caused by the addition of the glove. Figure 16 shows that the control surface mode has considerable deflection at the wing leading edge and inboard wing area. The glove covers this area of the wing and its mass and stiffness substantially reduce the modal response to the control surface deflections.

Mode shape could not be estimated.

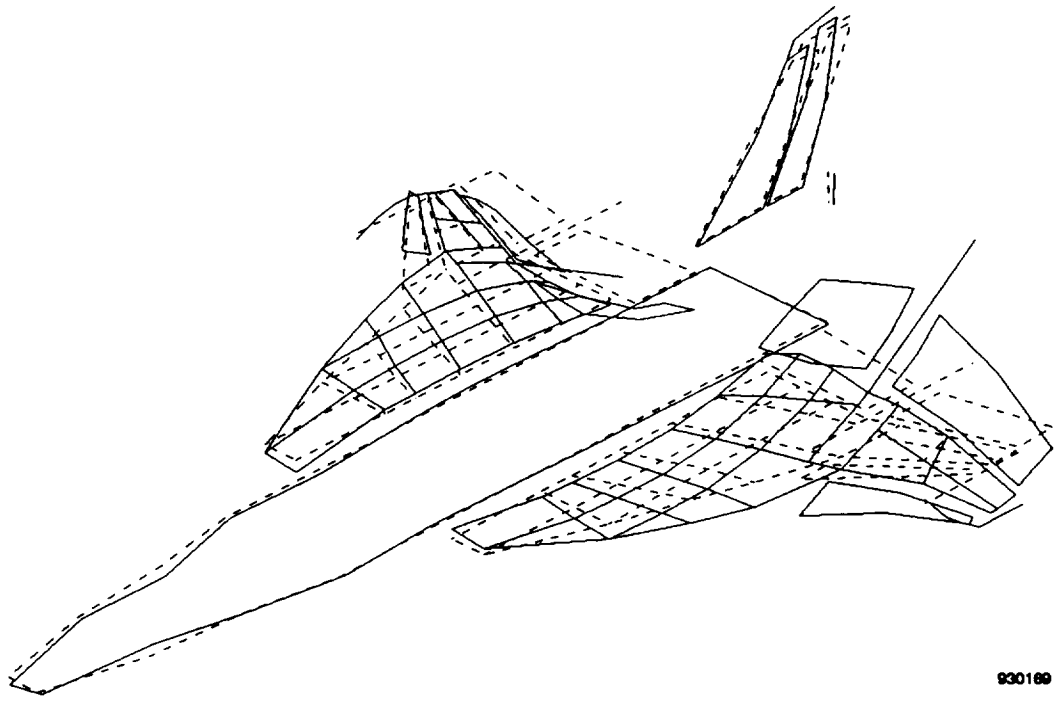
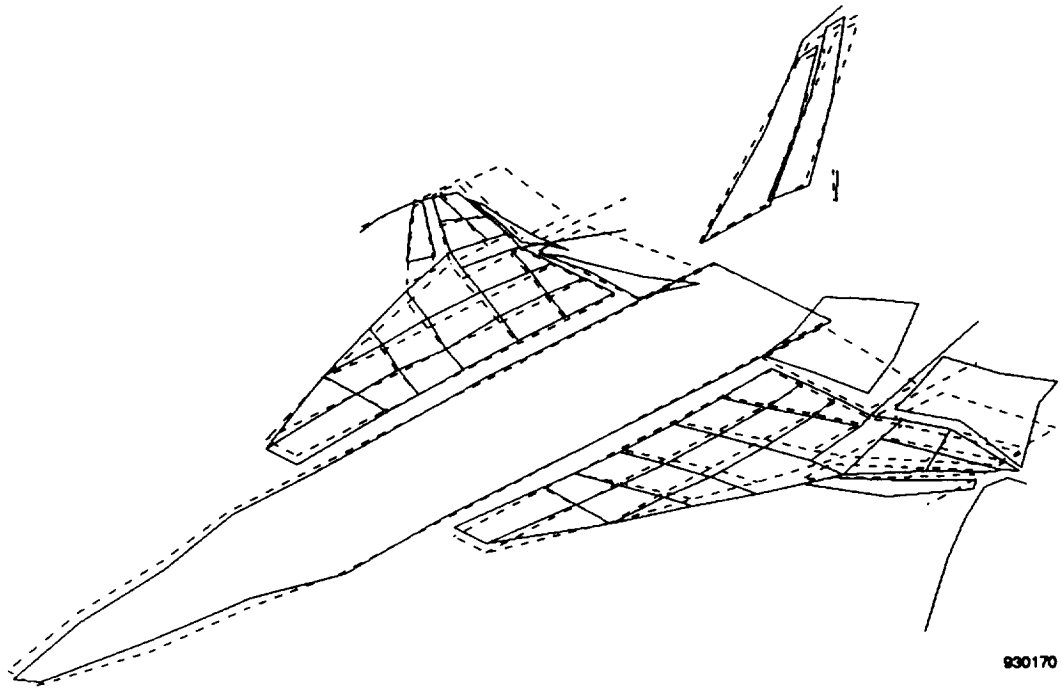
Figure 21. Aircraft mode shapes, antisymmetric control surface mode 2.

The second difference was identified in the second antisymmetric control surface mode. The data in Table 2 indicate an 8-percent shift in frequency from 22.2 to 24.0 Hz and a poor mode shape comparison. Figure 21 shows the mode shape. As was seen in the symmetric 26.4 Hz control surface mode, this mode has significant inboard wing motion on both the right and left wings. Again, the addition of the glove is in an area where the baseline GVT showed significant deflections. The total effect in the modified aircraft is stiffening, thereby reducing the deflection and increasing the frequency. The differences in the mode shapes are reflected in the MAC comparison. The change in mode shape was restricted to the glove area, so the vertical stabilizer and the fuselage motion remained unchanged.

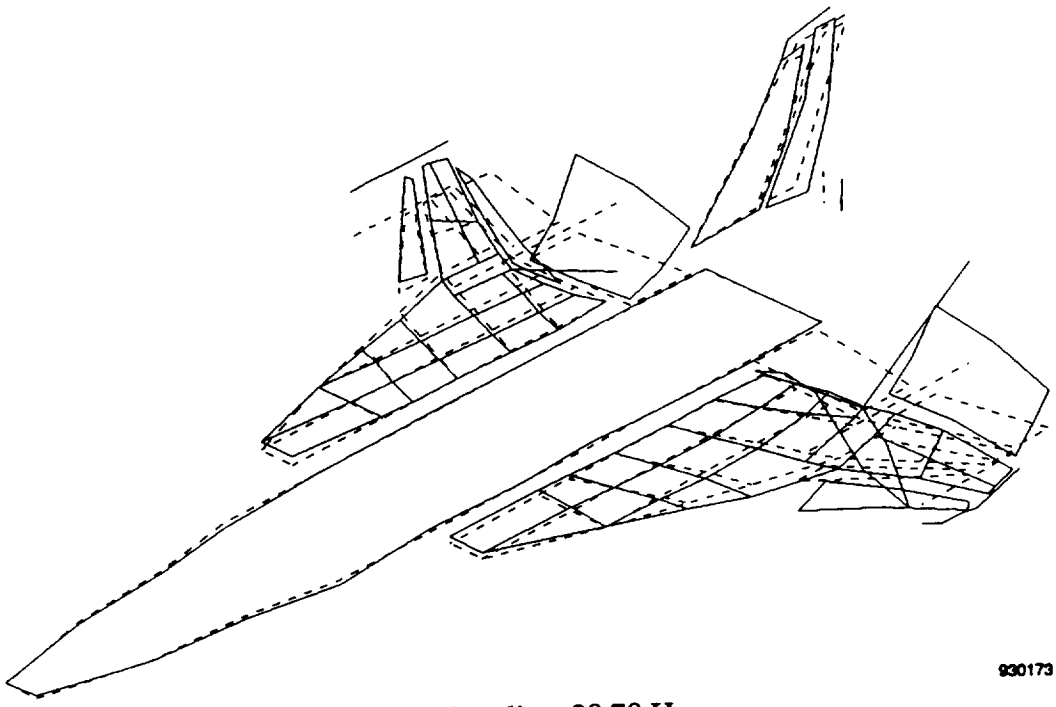
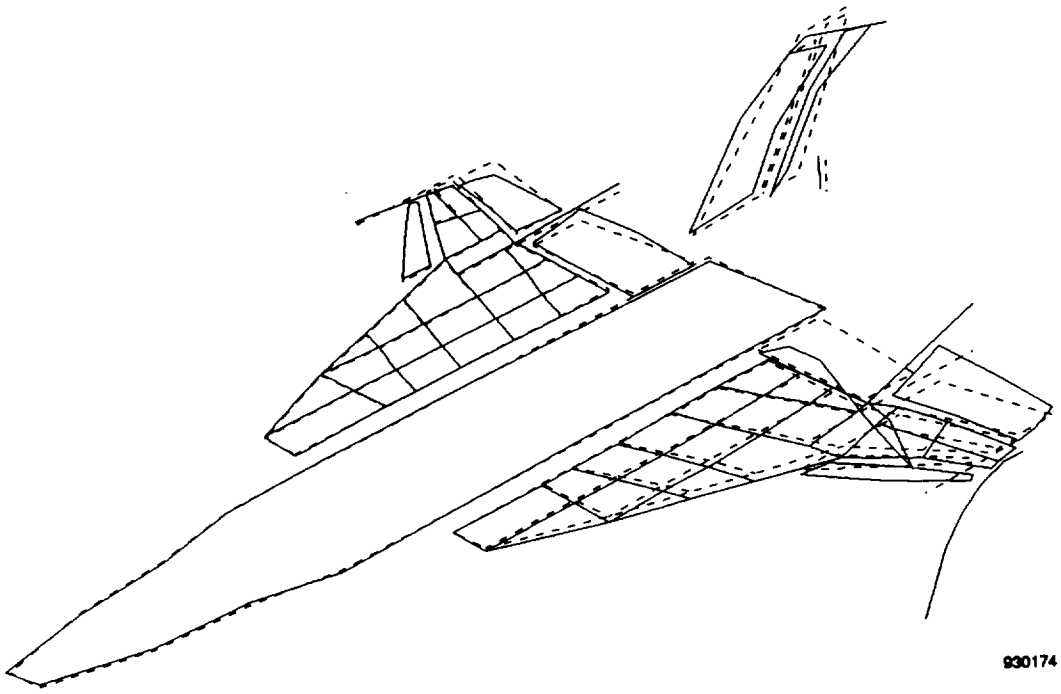
Figure 23. Aircraft mode shapes, antisymmetric control surface mode 4.

The third and final difference in the modal data was observed in the fourth antisymmetric control surface mode (fig. 23). The mode shape comparison shows a low MAC value of 0.295. The mode shape is asymmetric now but originally was antisymmetric. One possible explanation is that the 26.4-Hz symmetric mode (fig. 16) was shifted up to 28 Hz because of the glove and coupled with the 28.8-Hz antisymmetric mode. The distinct changes in mode shape before and after the modification resulted in the low MAC value.

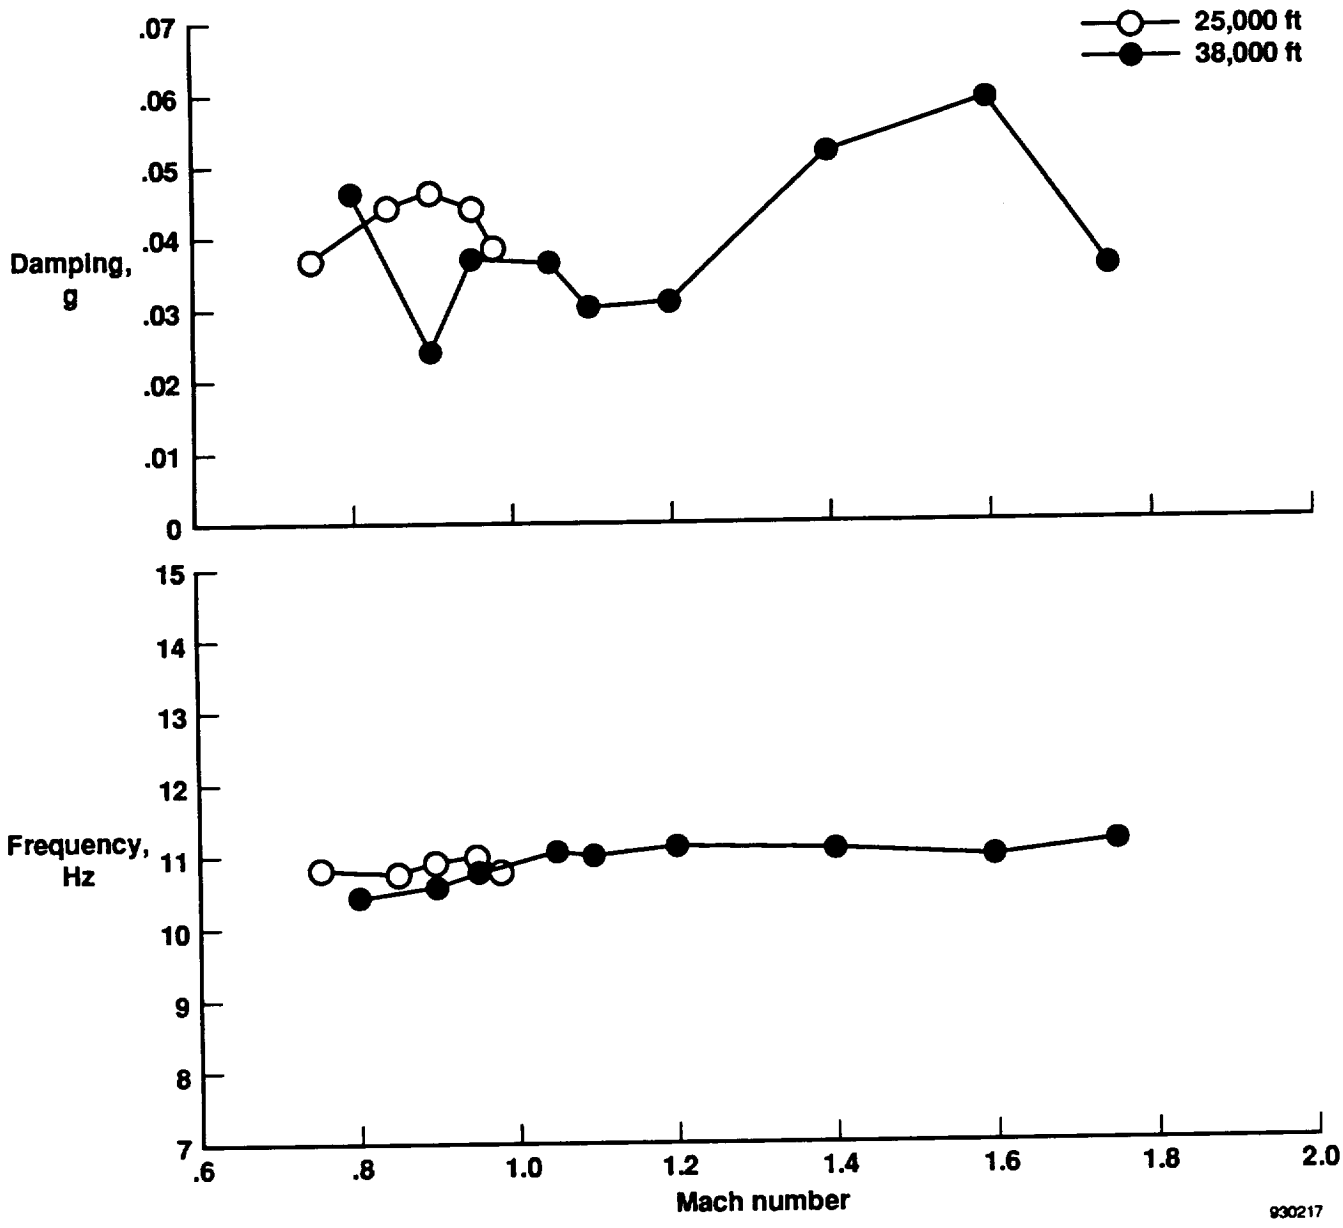
Figure 41. Antisymmetric wing bending flight test data.

The modal frequency and damping estimates were satisfactory. In figure 41 an adverse trend is evident at Mach 1.1 and above. The real-time monitoring of these modes did not indicate that a structural instability was near. The damping values are considered conservative using atmospheric turbulence as the only excitation. In reference 17, an experiment comparing forced structural excitation with random atmospheric turbulence showed that random atmospheric turbulence produced damping values that were lower by about a factor of 2.

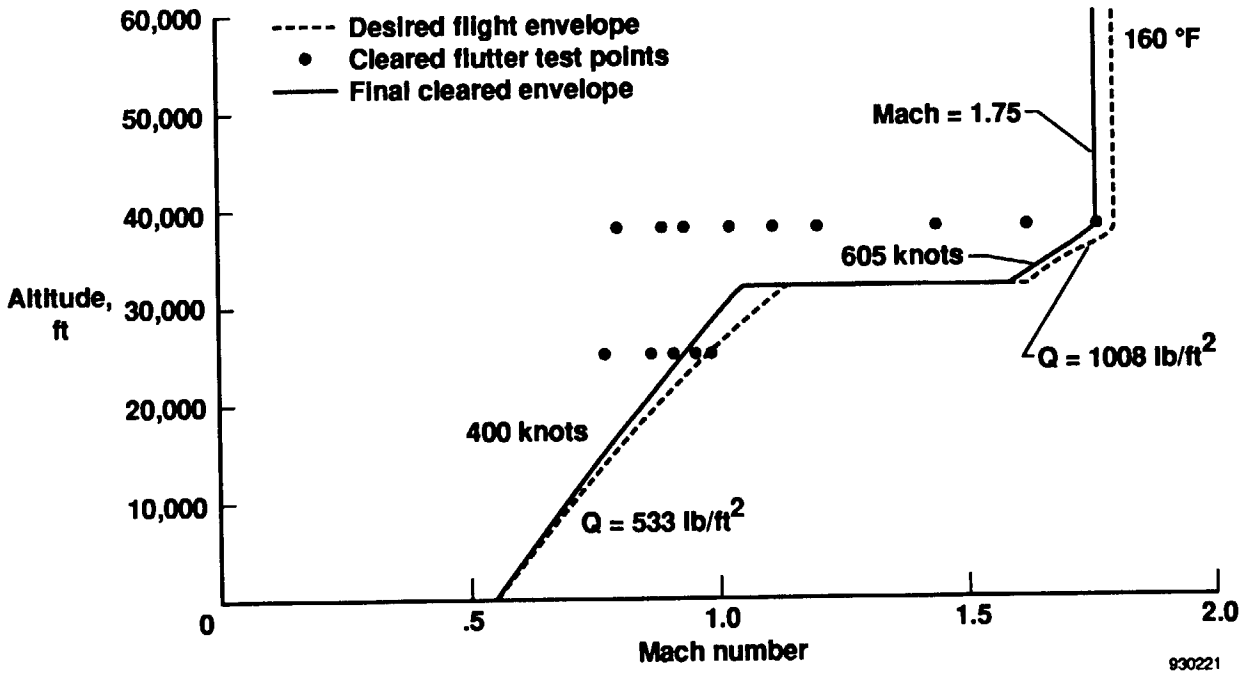
Figure 45. Final cleared flutter envelope.

The envelope cleared for the experiment was an airspeed of 400 knots up to an altitude of 32,000 ft, then a maximum speed of 605 knots through 38,000 ft, and finally a maximum speed of 1.75 Mach above 38,000 ft. This slightly smaller envelope from the project envelope was given because it is easier for a pilot to maintain airspeed than dynamic pressure. Figure 45 shows this envelope.
